Upper Wimmera Flood Investigation Final Report

Reference: R.M8460.009.01.Final.docx
Date: 30 June 2014

Prepared for: Wimmera Catchment Management Authority

Prepared by: BMT WBM Pty Ltd (Member of the BMT group of companies)
In association with Michael Cawood and Associates

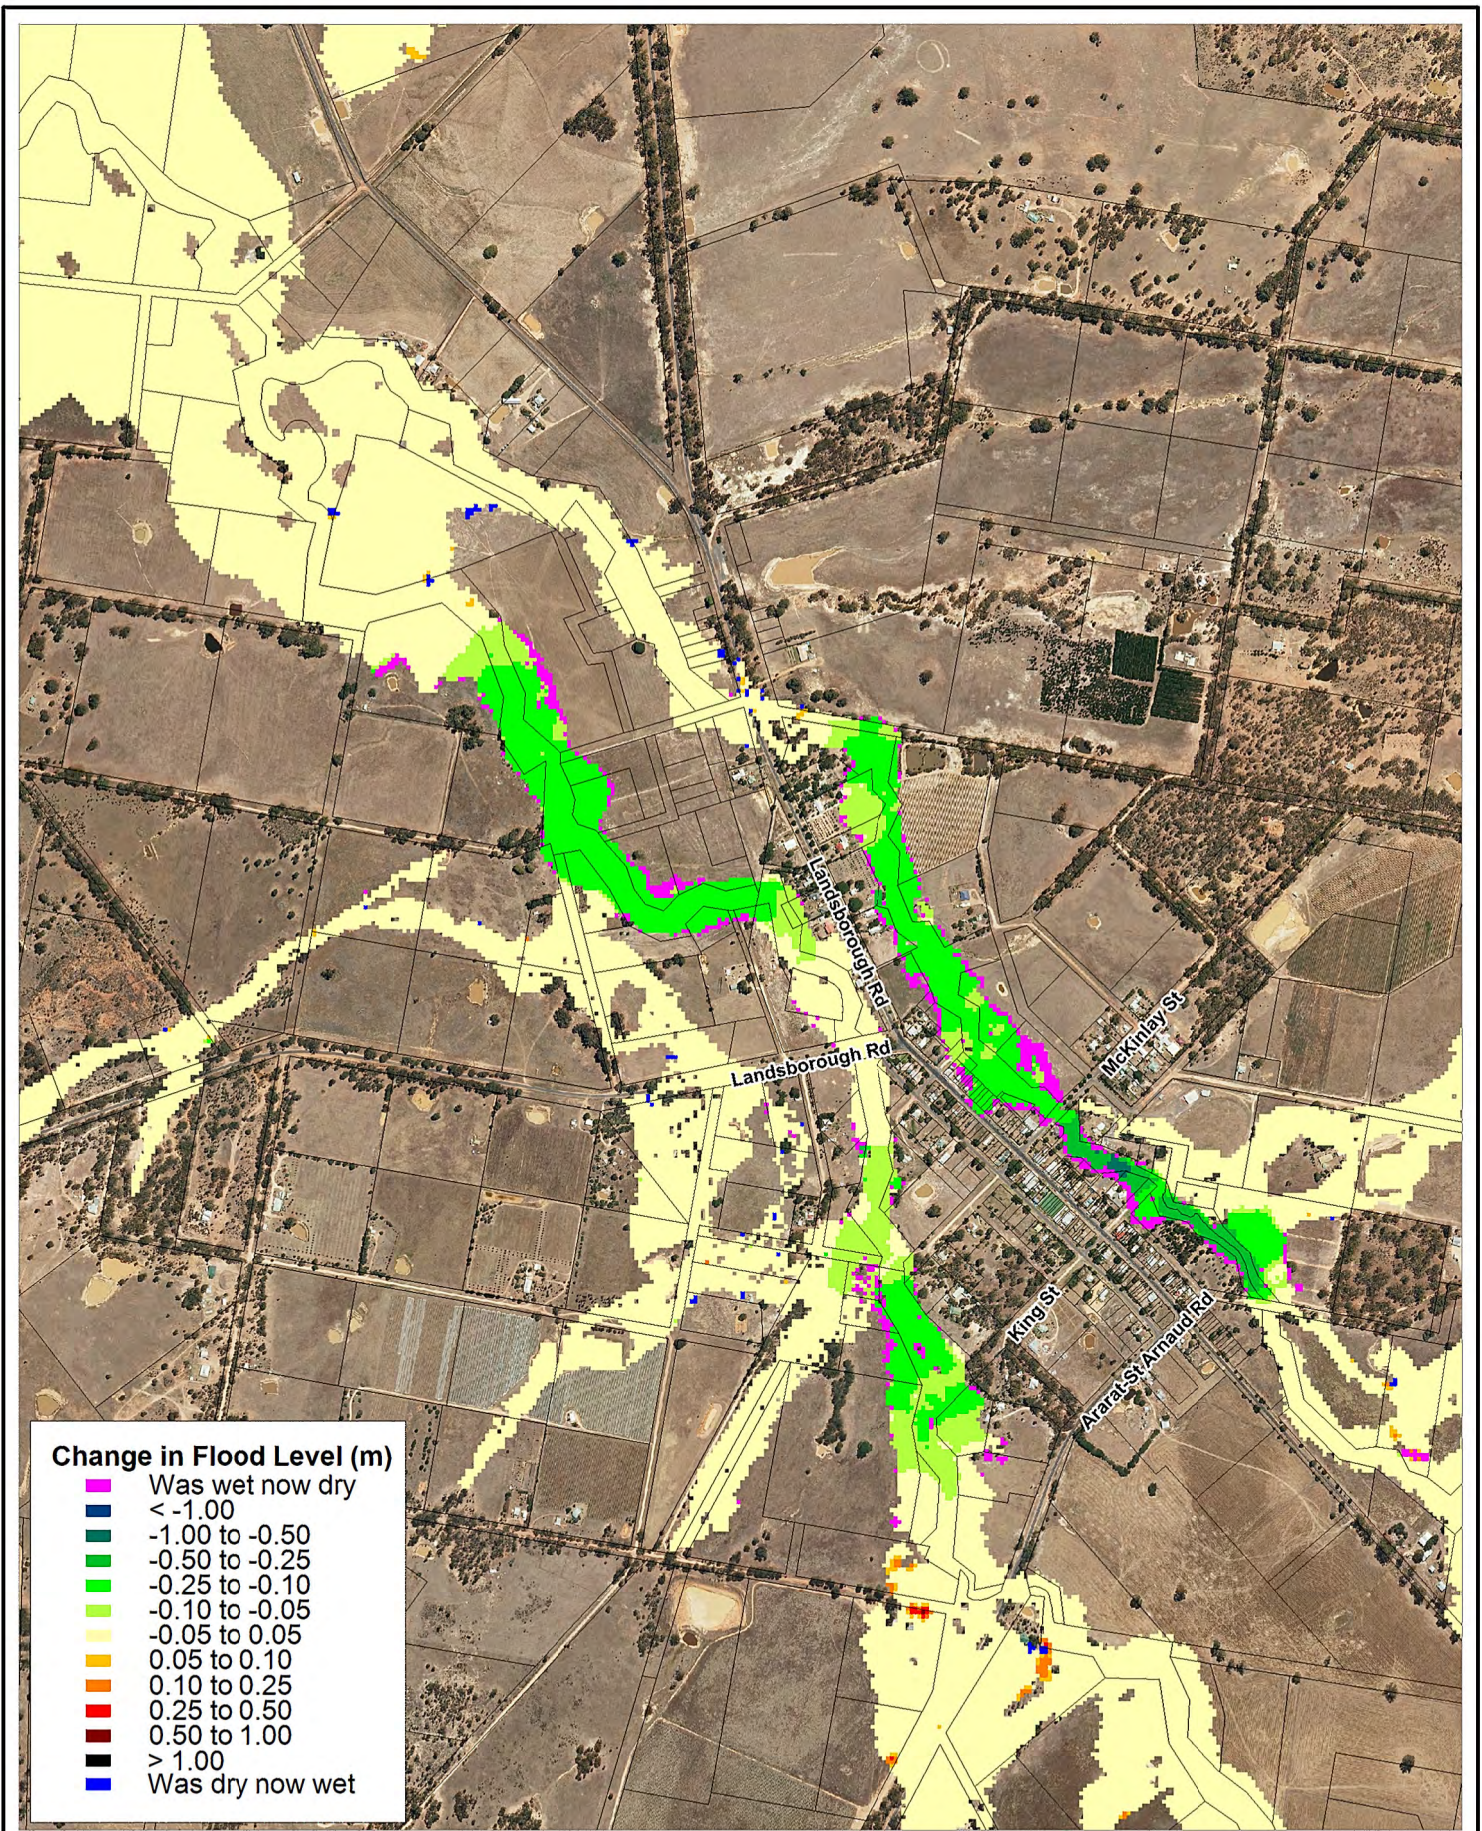
Title:
**Upper Wimmera Flood Investigation - Mitigation Option 1
 Vegetation Removal - 1% AEP Flood Height Impacts**

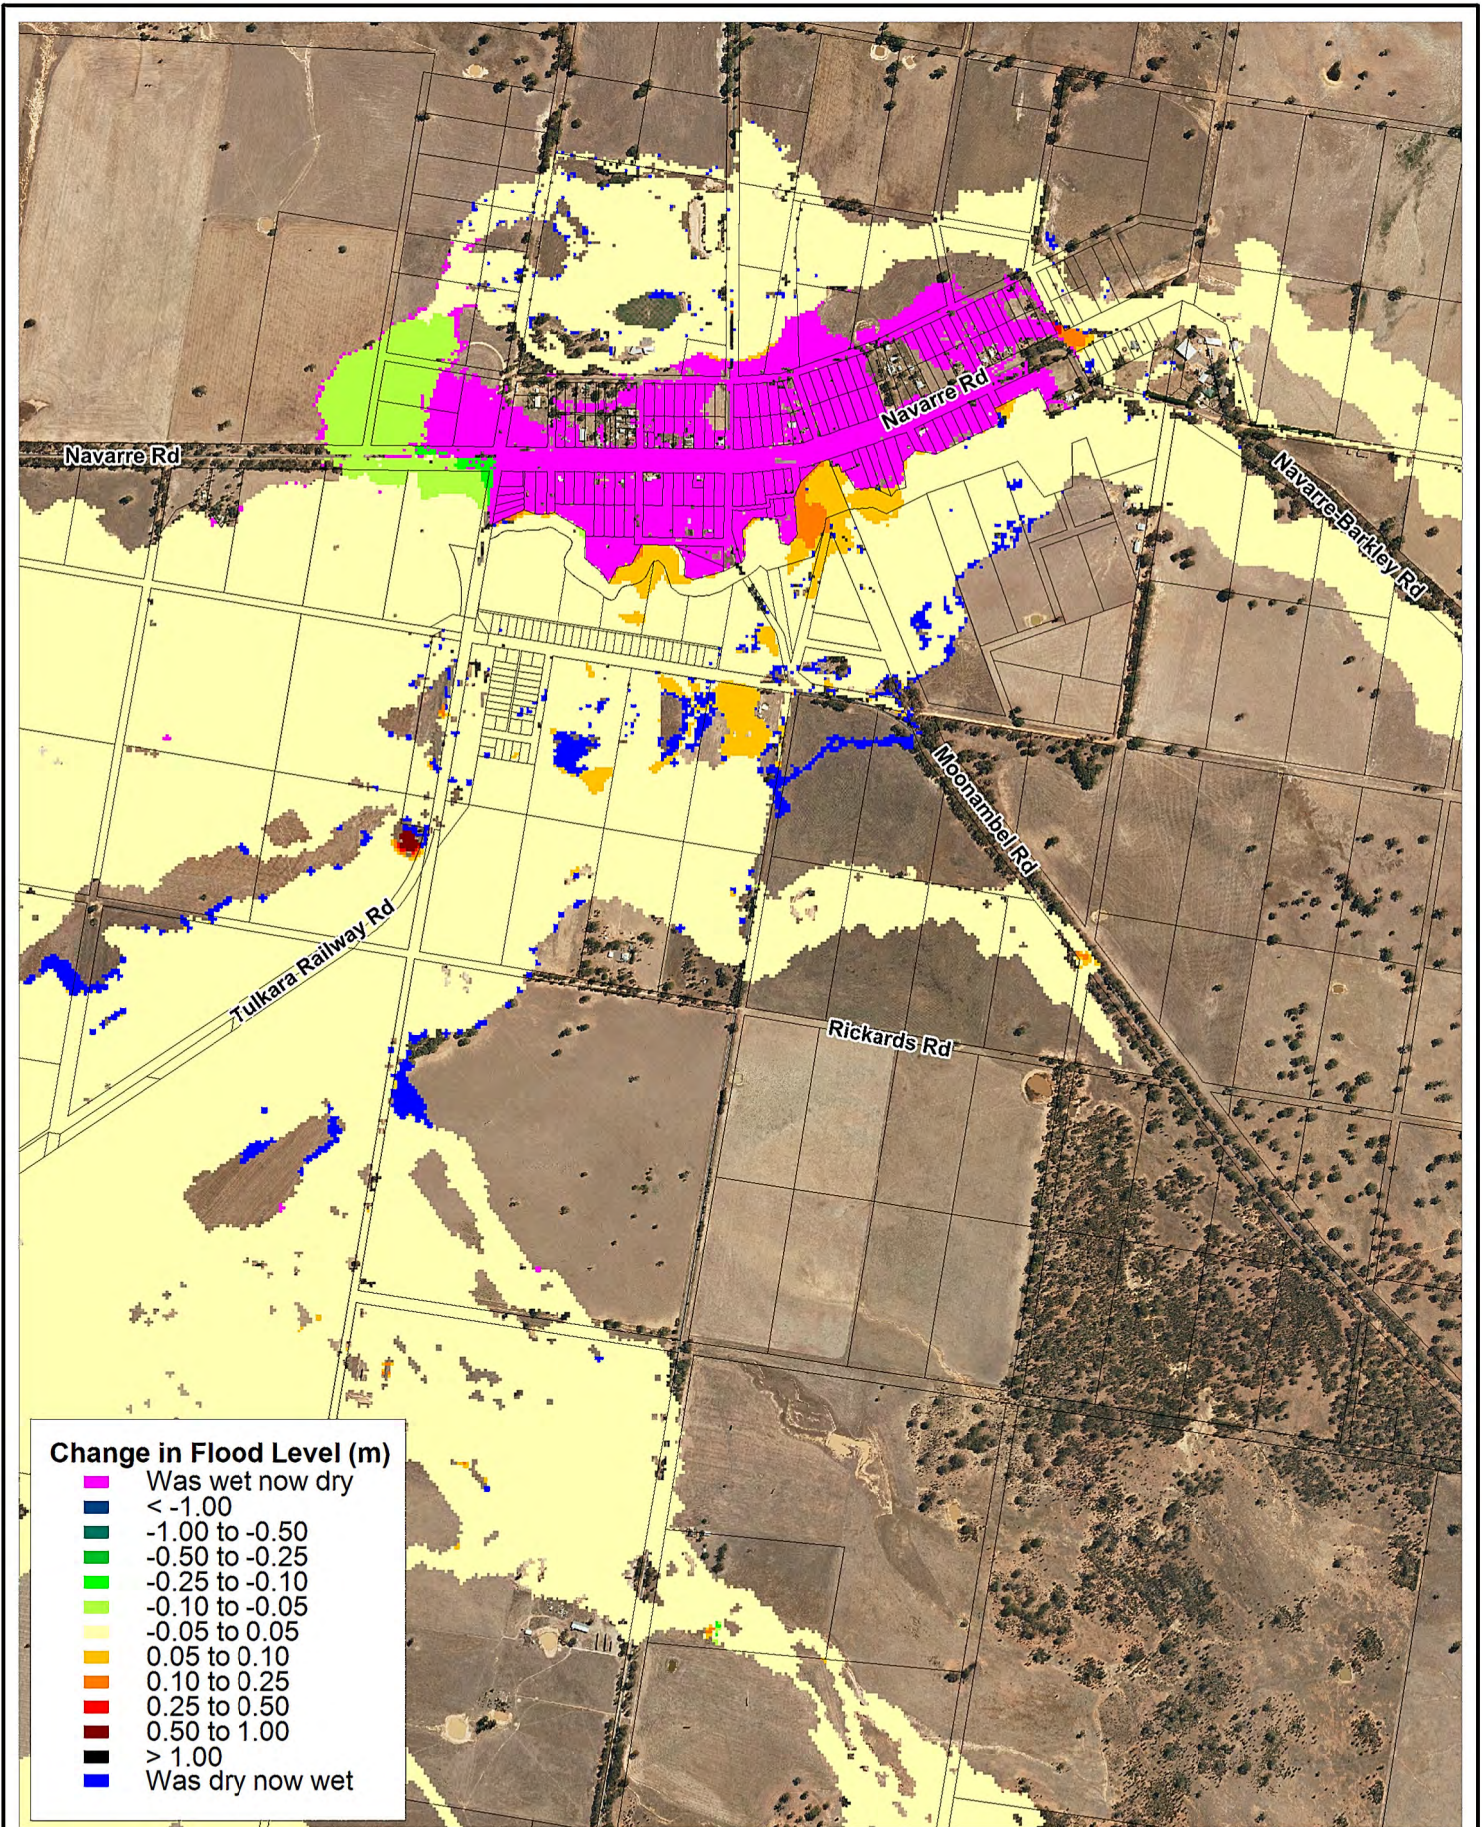
Title:
**Upper Wimmera Flood Investigation - Mitigation Option 2
 Levees for Navarre - 1% AEP Flood Height Impacts**

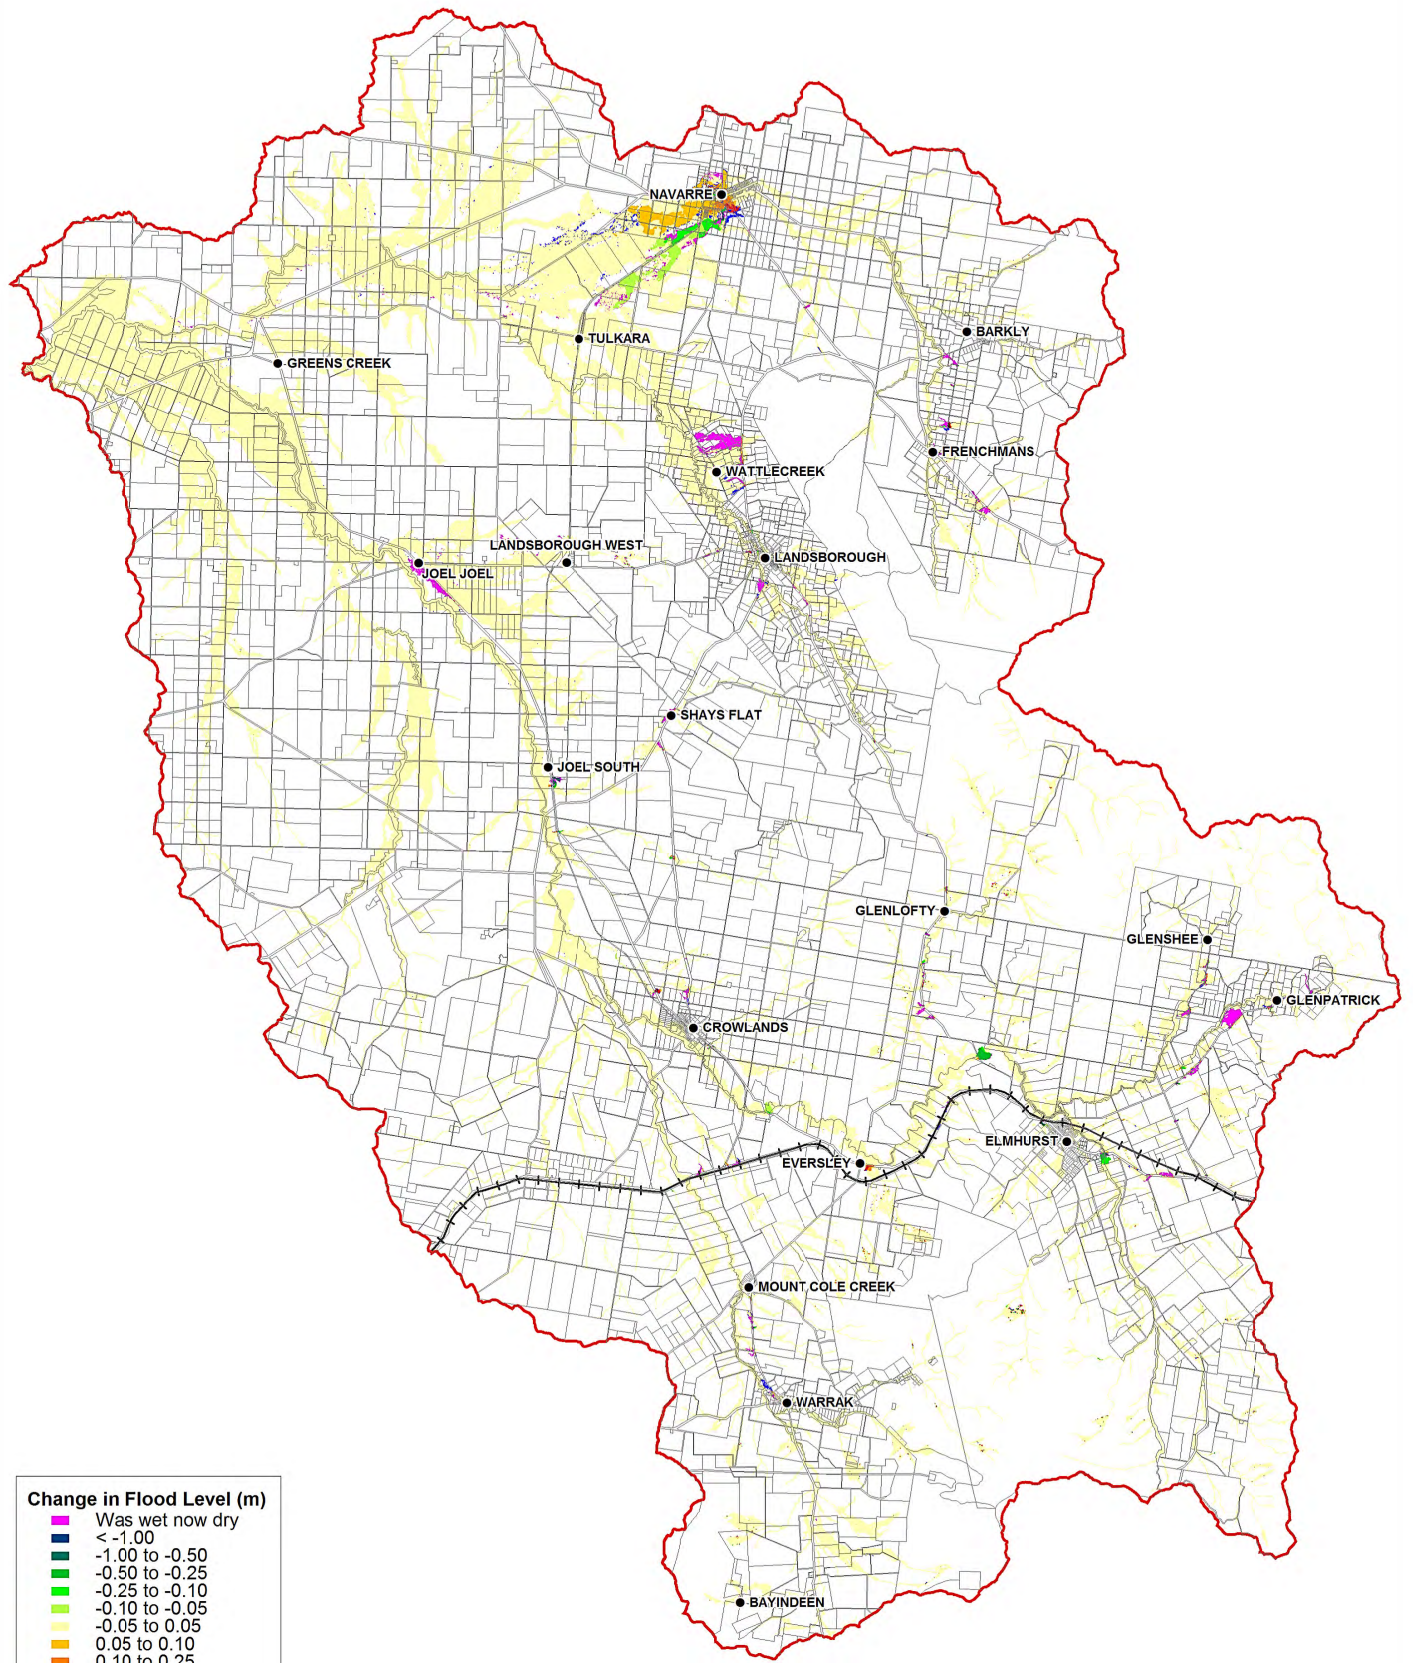
Title:
Upper Wimmera Flood Investigation - Mitigation Option 3
Town Access (Road Raising) - 1% AEP Flood Height Impacts
